INDOOR AIR QUALITY REASSESSMENT

**North Intermediate School
320 Salem Street
Wilmington, Massachusetts**

Prepared by:
Massachusetts Department of Public Health
Center for Environmental Health
Bureau of Environmental Health Assessment
May 2004

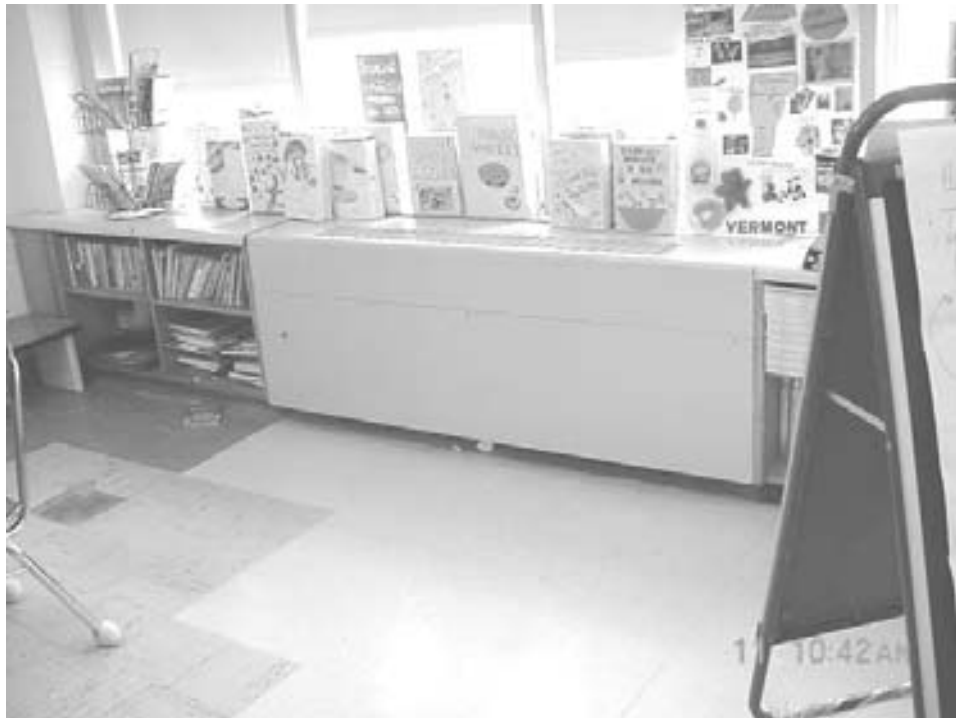
Picture 1

classrooms through an air diffuser located in the top of the unit. All univents were operating during the assessment. Fresh air in classrooms is supplemented by openable windows. In addition, wall mounted fans were installed in each classroom to facilitate airflow (Picture 3). Exhaust ventilation is provided by ducted, grated wall vents (Picture 4), powered by rooftop motors. All exhaust vents were operating during the assessment.

Classroom Unit Ventilator (Univent) 1960's Vintage

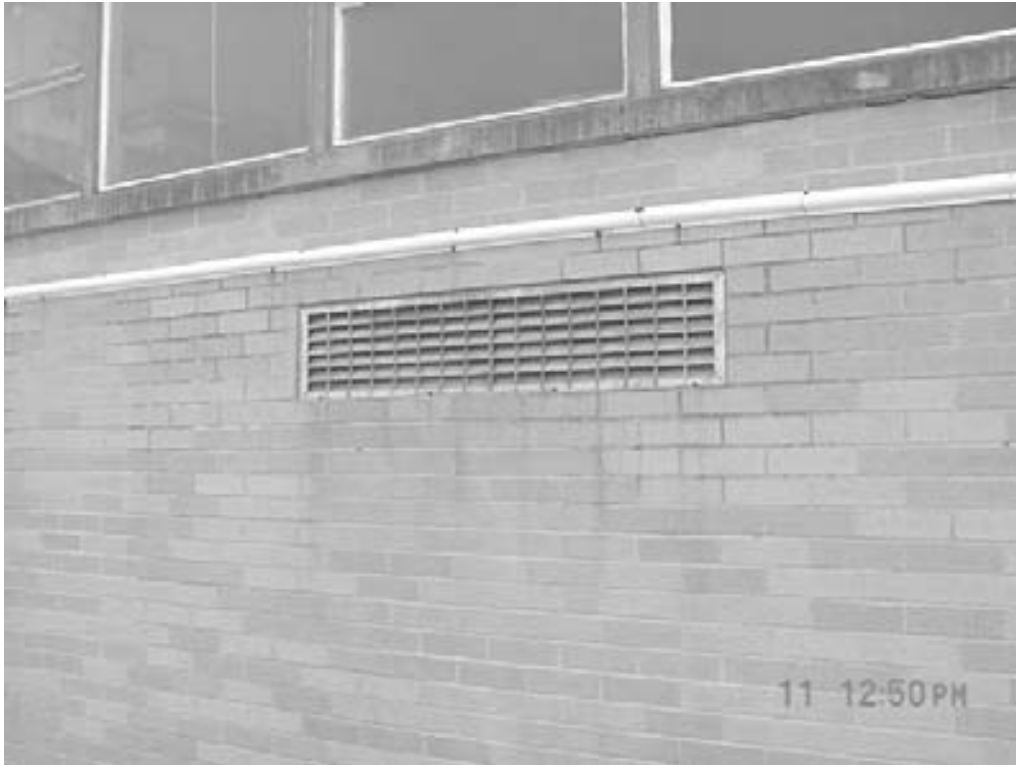
Picture 2

Univent Fresh Air Intake

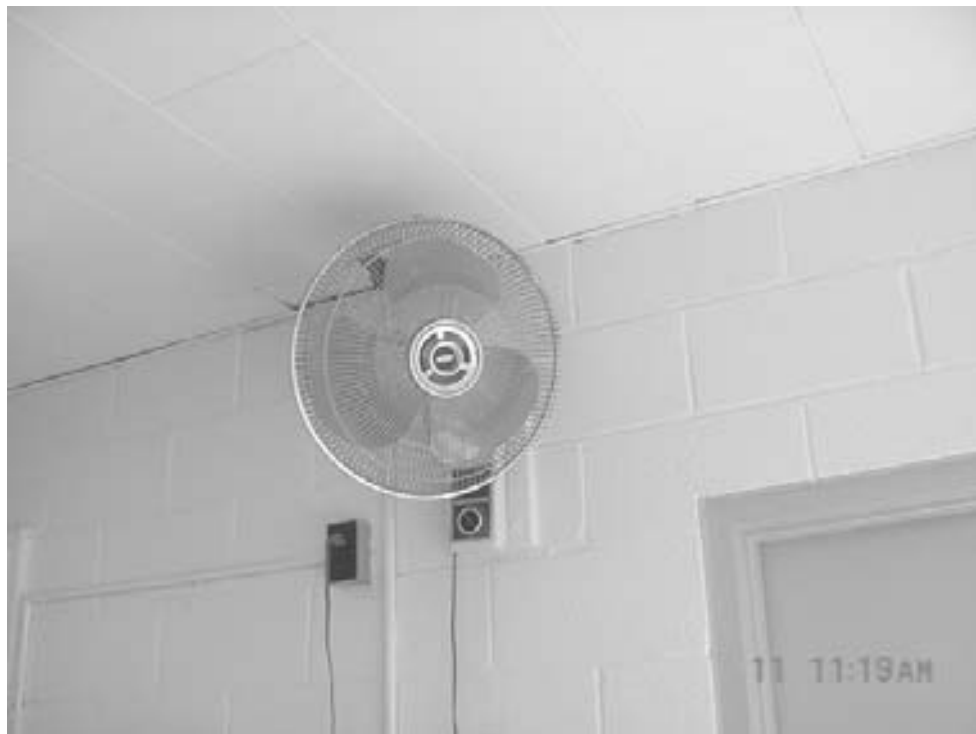
Picture 3

Wall-Mounted Fan Installed in Classroom

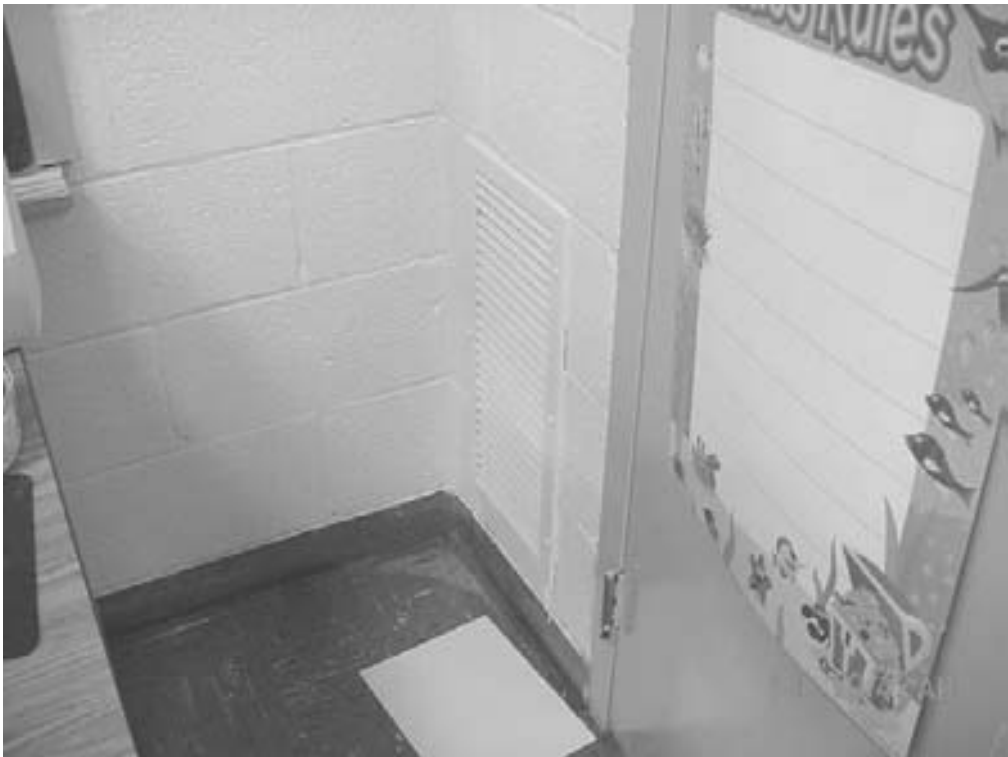
Picture 4

Classroom Exhaust Vent

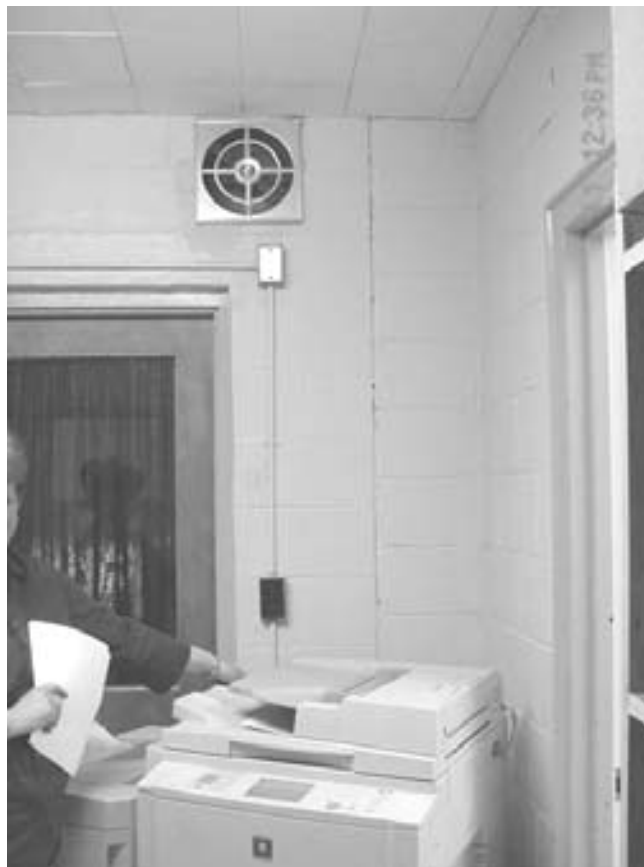
Picture 5

Several classrooms contained dry erase boards and dry erase board markers. Materials such as dry erase markers and dry erase board cleaners may contain VOCs, such as methyl isobutyl ketone, n-butyl acetate and butyl-cellusolve (Sanford, 1999), which can be irritating to the eyes, nose and throat. The teacher's workroom had several photocopiers. VOCs and ozone can be produced by photocopiers, particularly if the equipment is older and in frequent use. Ozone is a respiratory irritant (Schmidt Etkin, 1992). To help reduce excess heat and odors in these areas, school personnel should ensure that local exhaust ventilation (Picture 5) is activated while equipment is in use.

Local Exhaust Vent in Teacher's Workroom

| Location/Room | Occupants in Room | Temp (°F) | Relative Humidity (%) | Carbon Dioxide (*ppm) | CO (ppm) | TVOCs (ppm) | PM (µg/m³) | Windows Openable | Ventilation | | Remarks |
|---|---|---|---|---|---|---|---|---|---|---|--|
| Teacher's WK RM | | | | | | | | | | Y | 2 PC, Local exhaust off, Reactive |

6. Operate local exhaust vent in teacher's workroom during photocopier use.
7. Clean chalkboards and dry erase board trays regularly to avoid the build-up of particulates.

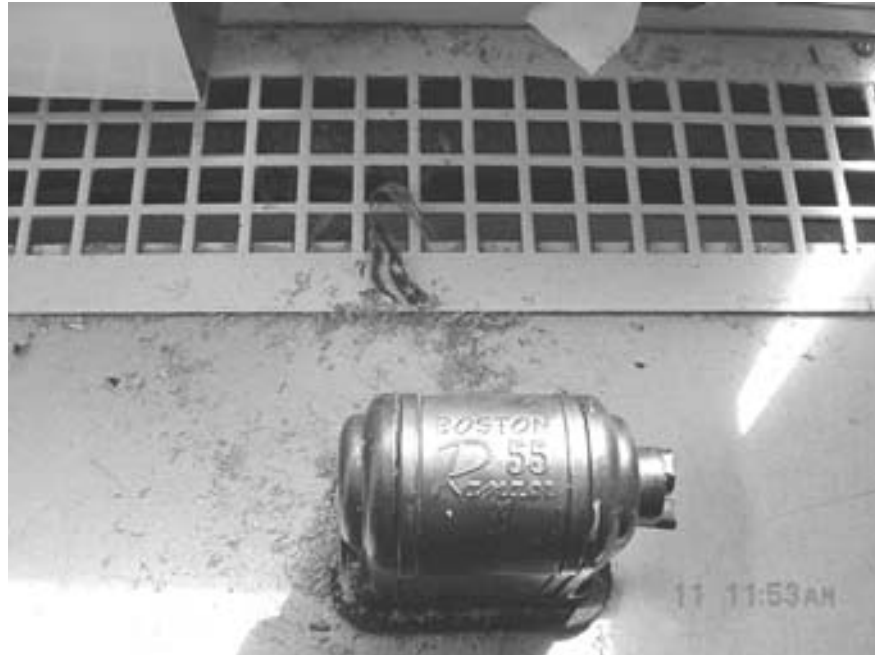
Picture 6

Other conditions that can affect indoor air quality were noted during the assessment. Accumulated chalk dust was noted in some classrooms. Chalk dust is a fine particulate that can easily become aerosolized. Once aerosolized, chalk dust can become irritating to eyes and the respiratory system. Similarly, pencil shavings were observed to be accumulating at the base of pencil sharpeners. In many classrooms, pencil sharpeners are installed on univents or radiators (Picture 6). When radiators or univents are operating, pencil shavings can become airborne, providing a source of eye and respiratory irritation.

Pencil Sharpener in Classroom

8. Relocate pencil sharpeners from the air diffusers of univents and radiators.
9. Store cleaning products properly and out of reach of students.
10. Consider discontinuing the use of tennis balls on chair legs.

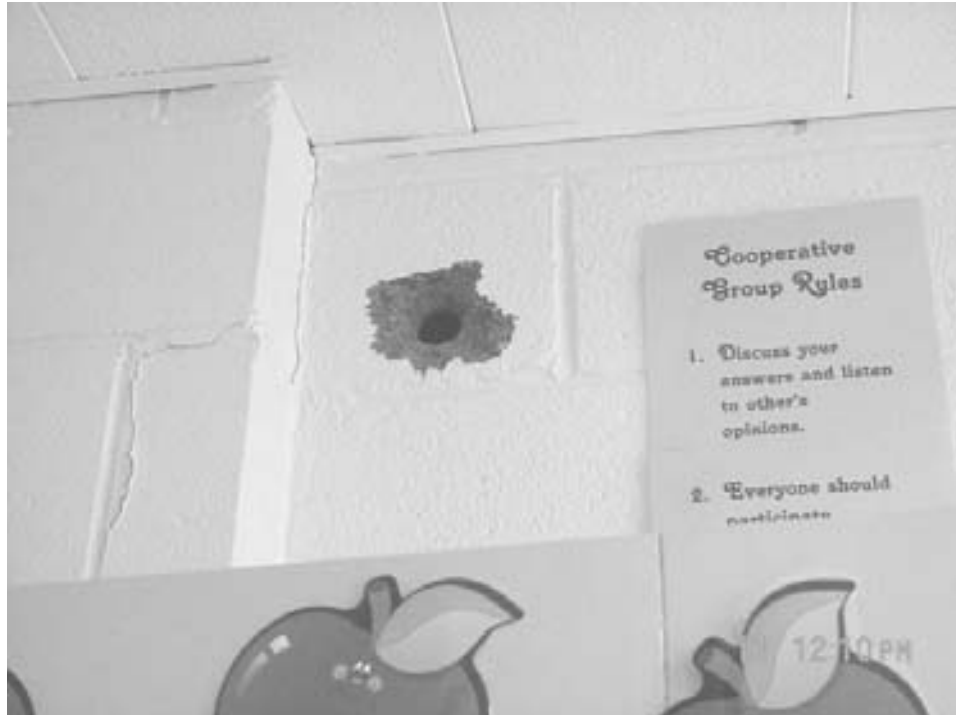
Picture 7

Lastly, open utility holes, missing ceiling tiles, and in classroom 208, spaces between the floor and the wall were observed (Pictures 7 and 8). Spaces between the floor and walls may be the result of settling. These breaches can serve as a means for odors, dusts and particulates to migrate between rooms and floors.

Open Utility Hole in Classroom

4. Replace any remaining water-stained ceilings.
5. Seal breaches around utility holes and spaces between walls and floors to prevent the migration of odors, dust and particulate matter between areas.

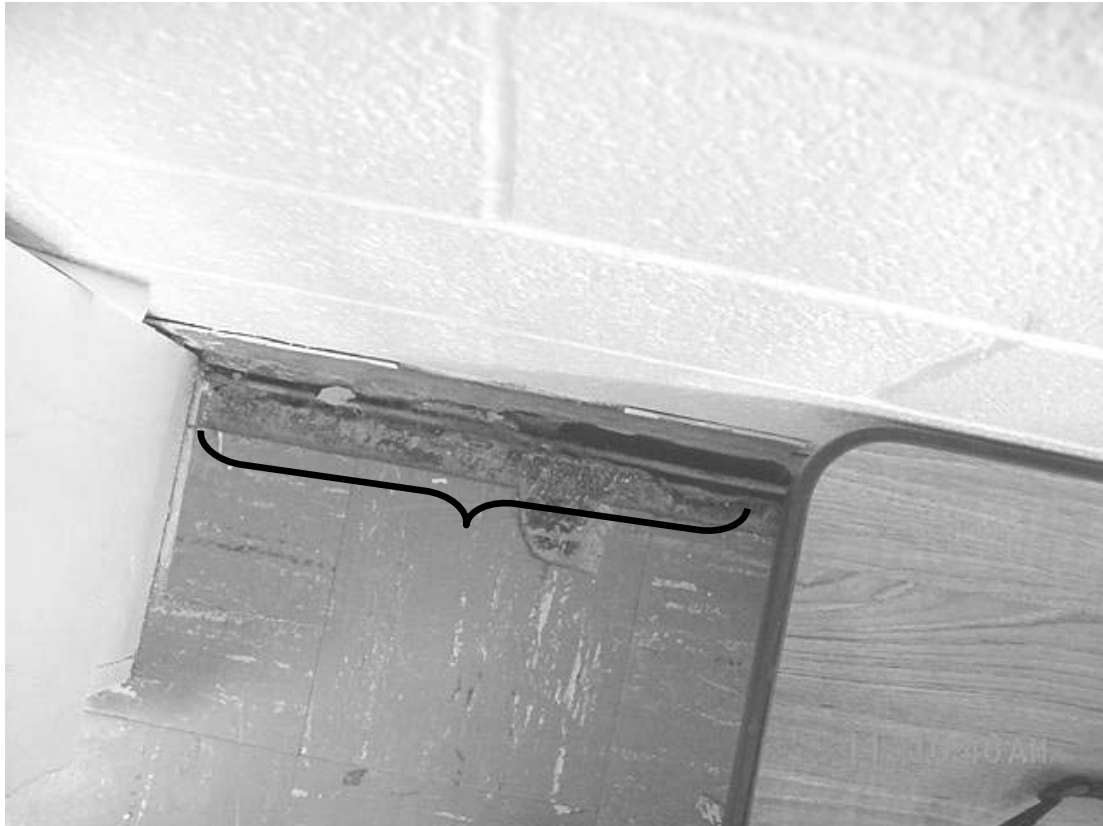
Picture 8

Space Between Wall and Floor in Classroom 208
